USAAMRDL TECHNICAL REPORT 73-78A

ARMORED STRUCTURAL HELICOPTER FUSELAGE STUDY

CONTRACT DAAJ02-72-C-0018
SIKORSKY AIRCRAFT
DIVISION OF UNITED AIRCRAFT CORPORATION
STRATFORD, CONNECTICUT

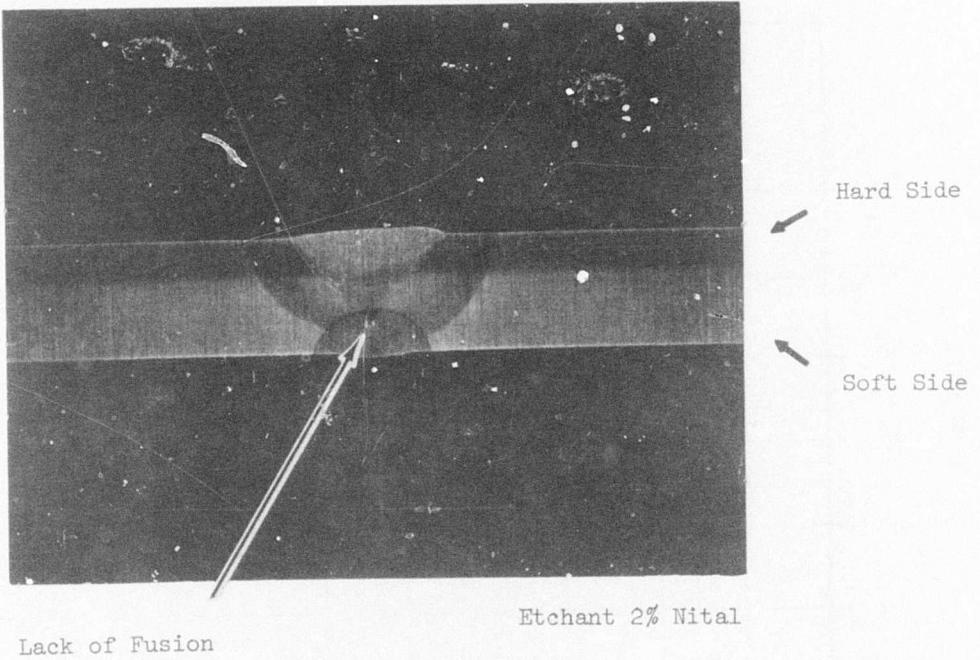
Photomicrograph of a transverse section of Dual Hardness Steel Weldment showing a three (3) pass weld with the last pass being made on the soft side. Also noticed was an area of lack of fusion as indicated by the lower arrow.

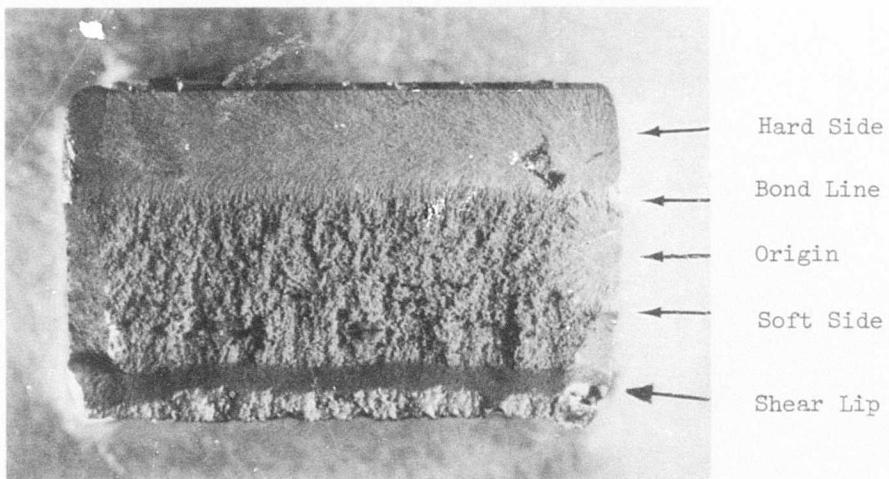
Figure 64. Typical Fracture Surface, Base Undamaged Fatigue Specimen.
~ 6.5X

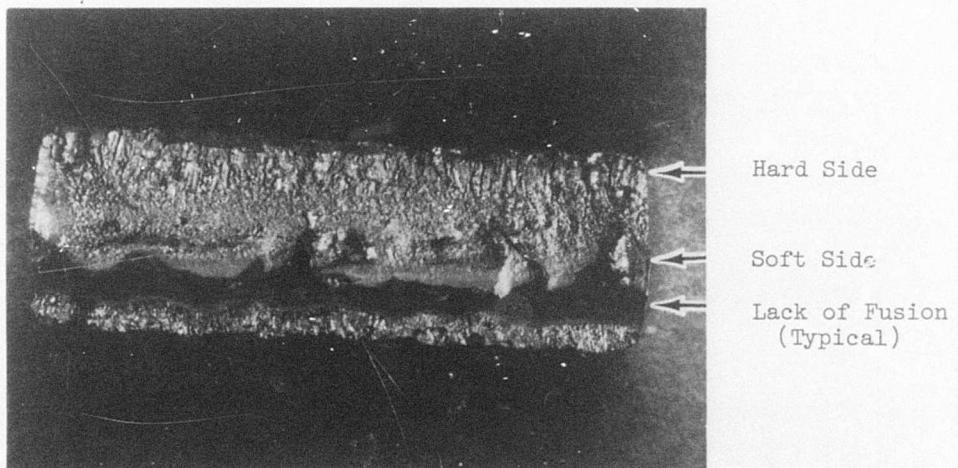
Figure 65. Typical Fracture Surface, Welded Undamaged Fatigue Specimen.
~ 4X

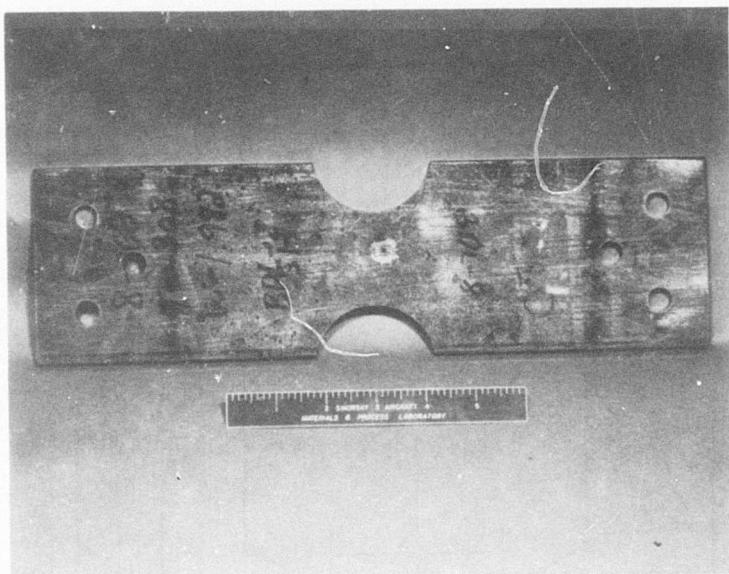
Figure 94. Base Damaged Fatigue Specimen With Hard Side Surface Damage.

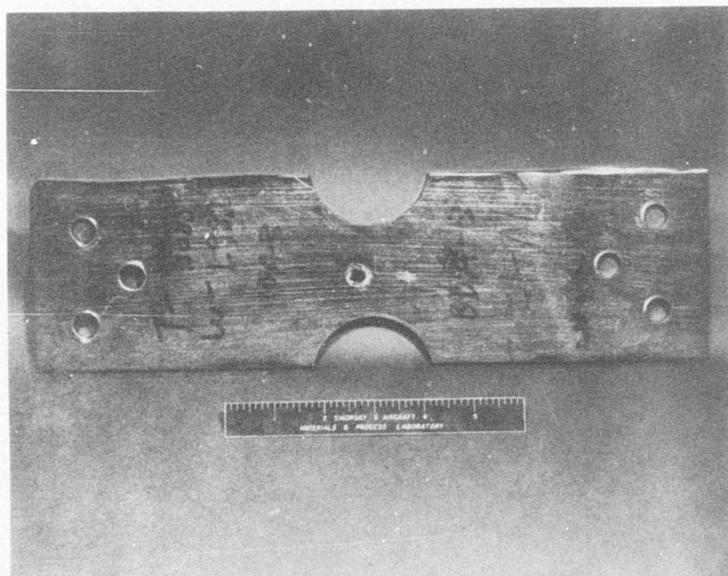
Figure 95. Base Damaged Fatigue Specimen With Through Hole.

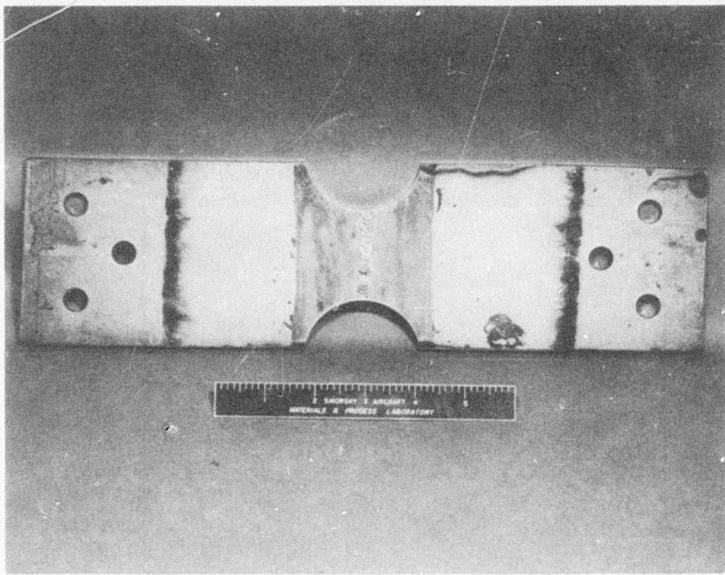
Typical specimen showing no damage due to defeat of projectile by protective plate.

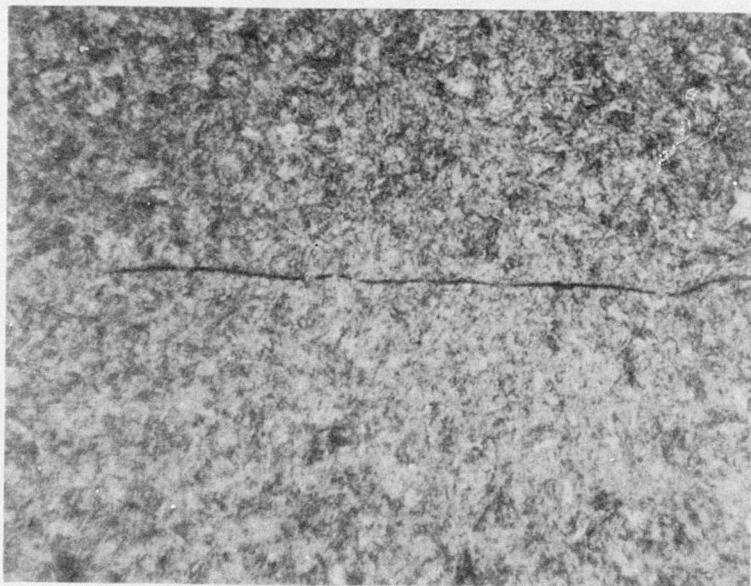
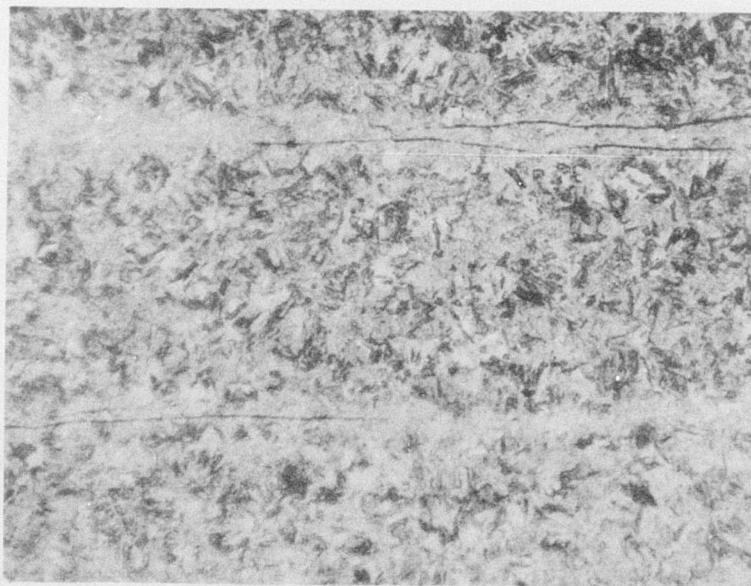
Figure 100. Typical Base Damaged Microstructural Appearance
Showing White Streaks and Associated Cracks.
~500X

The typical base damaged microstructural appearance of the hard and soft sides of the DHS used is shown in Figure 100. White streaks (adiabatic shear bands) and associated cracks were found on both the hard and soft sides of the material. They probably are formed by one or both of the following mechanisms: (1) adiabatic heating and rapid quenching in concentrated areas of high shear deformation; or (2) severe local plastic deformation and heating in tempered martensite (containing carbides and a high dislocation density), which cause the carbides to dissolve and to migrate to new dislocation sites (Reference 21).

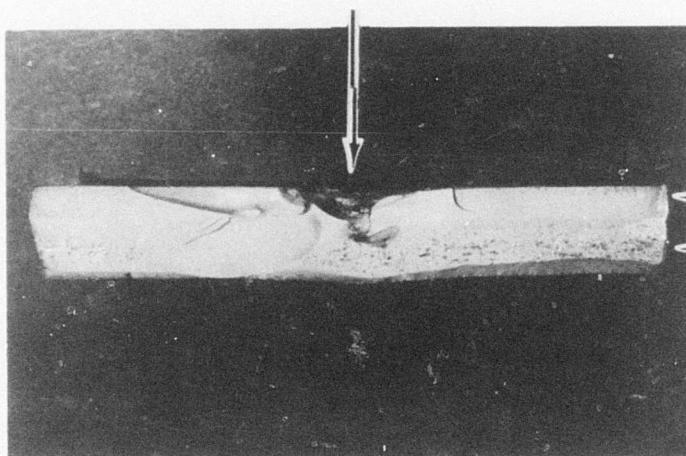
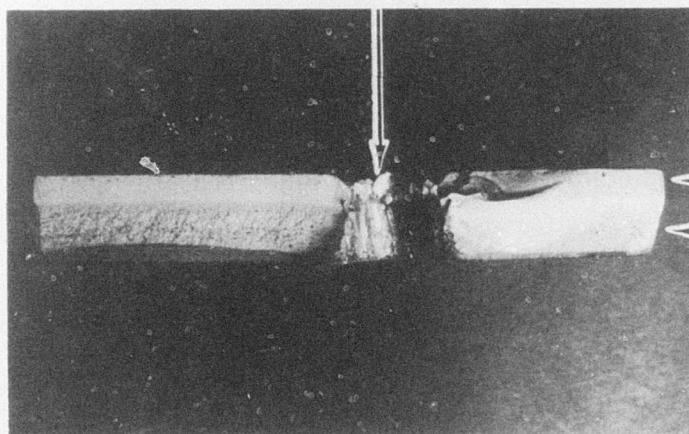
Figure 101. Typical Fracture Surfaces of Base Damaged Fatigue Specimens.
~1.7X

The base residual fatigue life specimens exhibited hard side surface cracking or a through hole from ballistic impacting. Through hole specimens exhibited residual fatigue life comparable to those with surface cracks, except at the highest test stress level. Crack origins of through hole specimens were located at hard side microcracks around the hole. Crack origins of surface damaged specimens were located at the base of one or more surface cracks in the hard side. In both types of base specimens, the crack initiated and grew faster in the higher strength, lower fracture toughness hard side. The crack propagated from the hard side into the soft side and stayed subsurface on the soft side. Crack growth was predominantly in the flat or plane-strain mode and brittle in nature. The base specimens exhibited a fatigue crack propagation region which was typically 70 percent of the cross-sectional area. Figure 101 shows typical fracture surfaces of both surface-damaged and through hole base residual fatigue life specimens.

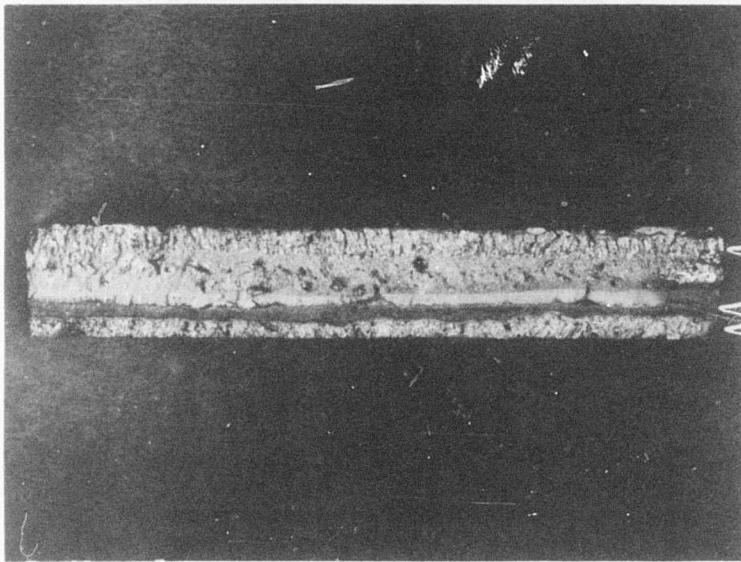
Figure 102. Typical Fracture Surface, Welded Damaged Fatigue Specimen.
~2.2X

Crack origins and propagation occurred subsurface in the fusionless area (due to lack of penetration) in the soft side of the welded damaged specimens. The crack propagated along the path of least resistance, i.e., the fusionless area in the center of the weld bead. The welded damaged specimens had a fatigue crack propagation area which was typically 50 percent of the cross-sectional area. The typical fracture surface of a welded residual fatigue life specimen is shown in Figure 102.

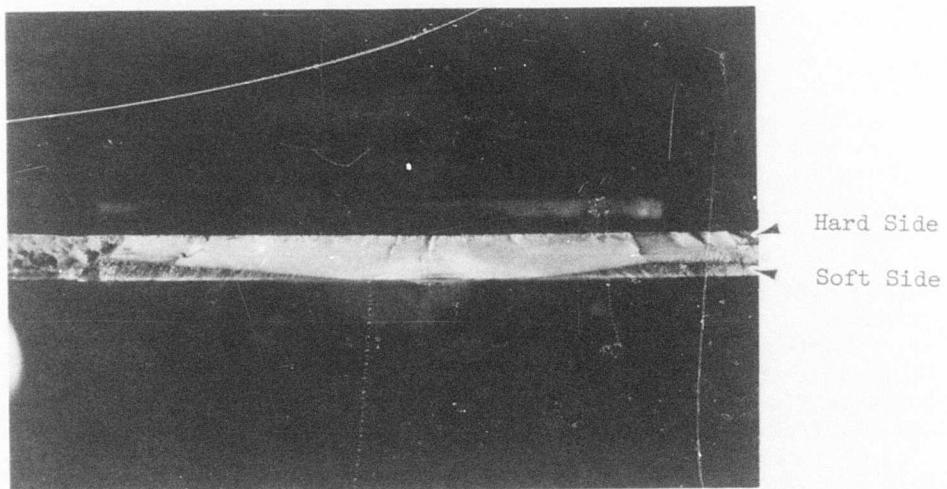
Figure 107. Fracture Surface, Welded Damaged Crack Propagation Specimen.
~1X

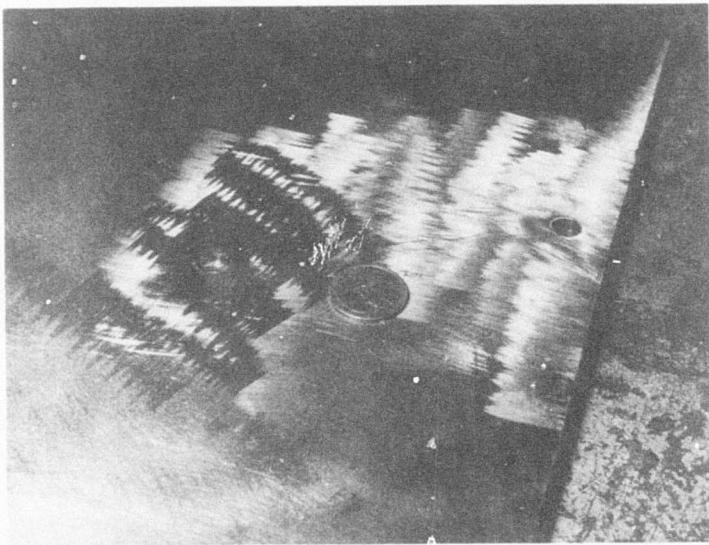
Figure 116. Typical Residual Stress Crack After Stop-Drilling.

The first type of cracking was noted in the armor details prior to any welding. During flattening, cracks up to 11 inches in length had occurred in several panels, which were either replaced or repaired prior to shipment. However, a number of panels were received with cracks which generally started at an edge and ran perpendicularly for distances up to 5 inches. most occurred on the hard side only, although a few through cracks were noted.

All of these cracks were repaired prior to assembly. The repair procedure consisted of stop-drilling the ends of the crack (Figure 116), grinding out the crack (Figure 117) and puddling a weld into the resulting groove. Dye penetrant inspection was conducted after grinding to assure that the crack had been removed, and again after welding. The majority of these repairs were made with the 4130-type wire.

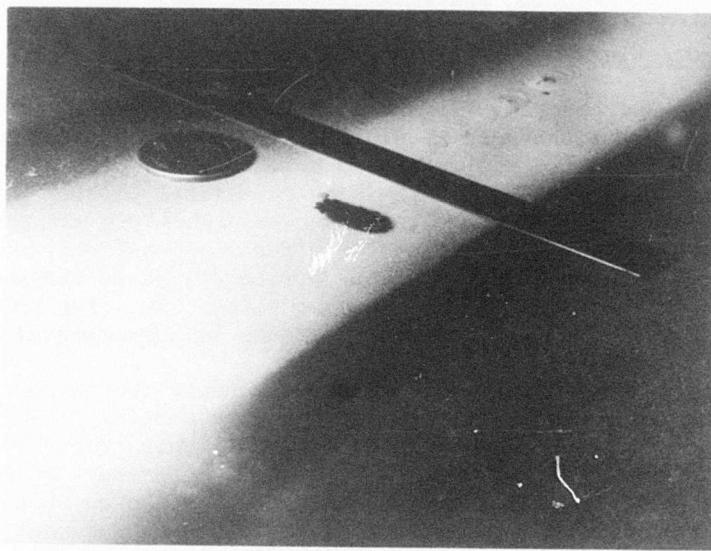
Figure 118. Secondary Residual Stress Crack.

Similar cracks occasionally occurred during welding, either spontaneously, or from very small edge cracks (Figure 118). These were similarly repaired by stop-drilling, grinding and welding (Figure 119).

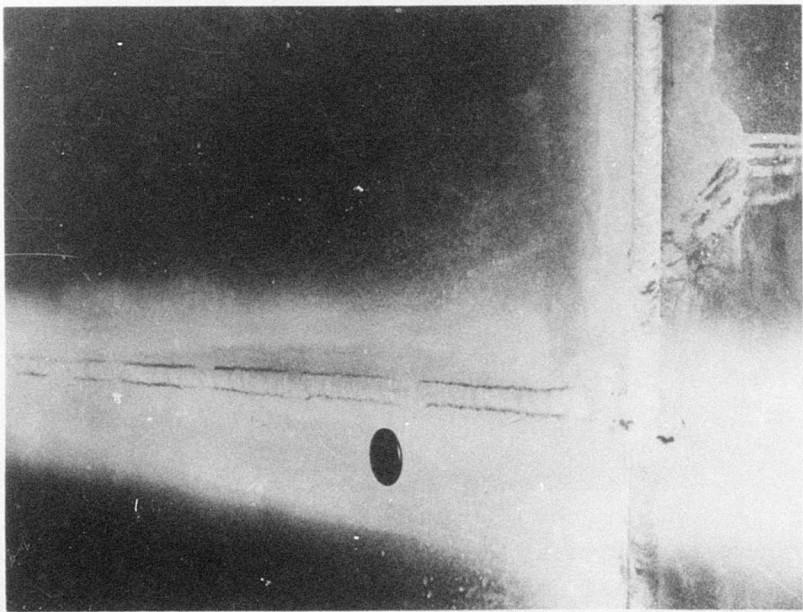
Figure 121. Fusion Line Cracking Around Repair Plug Weld.

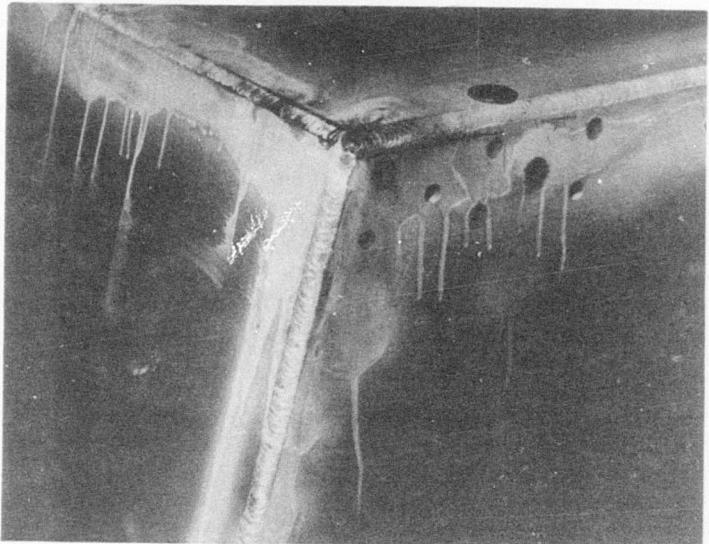
Figure 122. Typical Corner Heat-Affected Zone Crack.

These cracks also occurred parallel to the weld, but were typically located approximately 0.1 inch away from the edge of the bead. They occurred only where plates were welded together at an angle to form an edge, such as side to floor, or aft bulkhead to side (Figures 122 and 123).

greatly limit the use of automated welding techniques, which have always been an aim in these development programs. Welding from the ends of the joint to the center was also tried, in order to provide greater heat flow from the weld, and did seem to somewhat reduce the extent of cracking. However, since most of the subassembly welding had been completed, full use of this approach could not be made. Replacement of the armor with material having lower residual stresses was also considered. This, however, implied extensive development of heat-treating and forming techniques and would have resulted in increased costs and/or a long program delay.

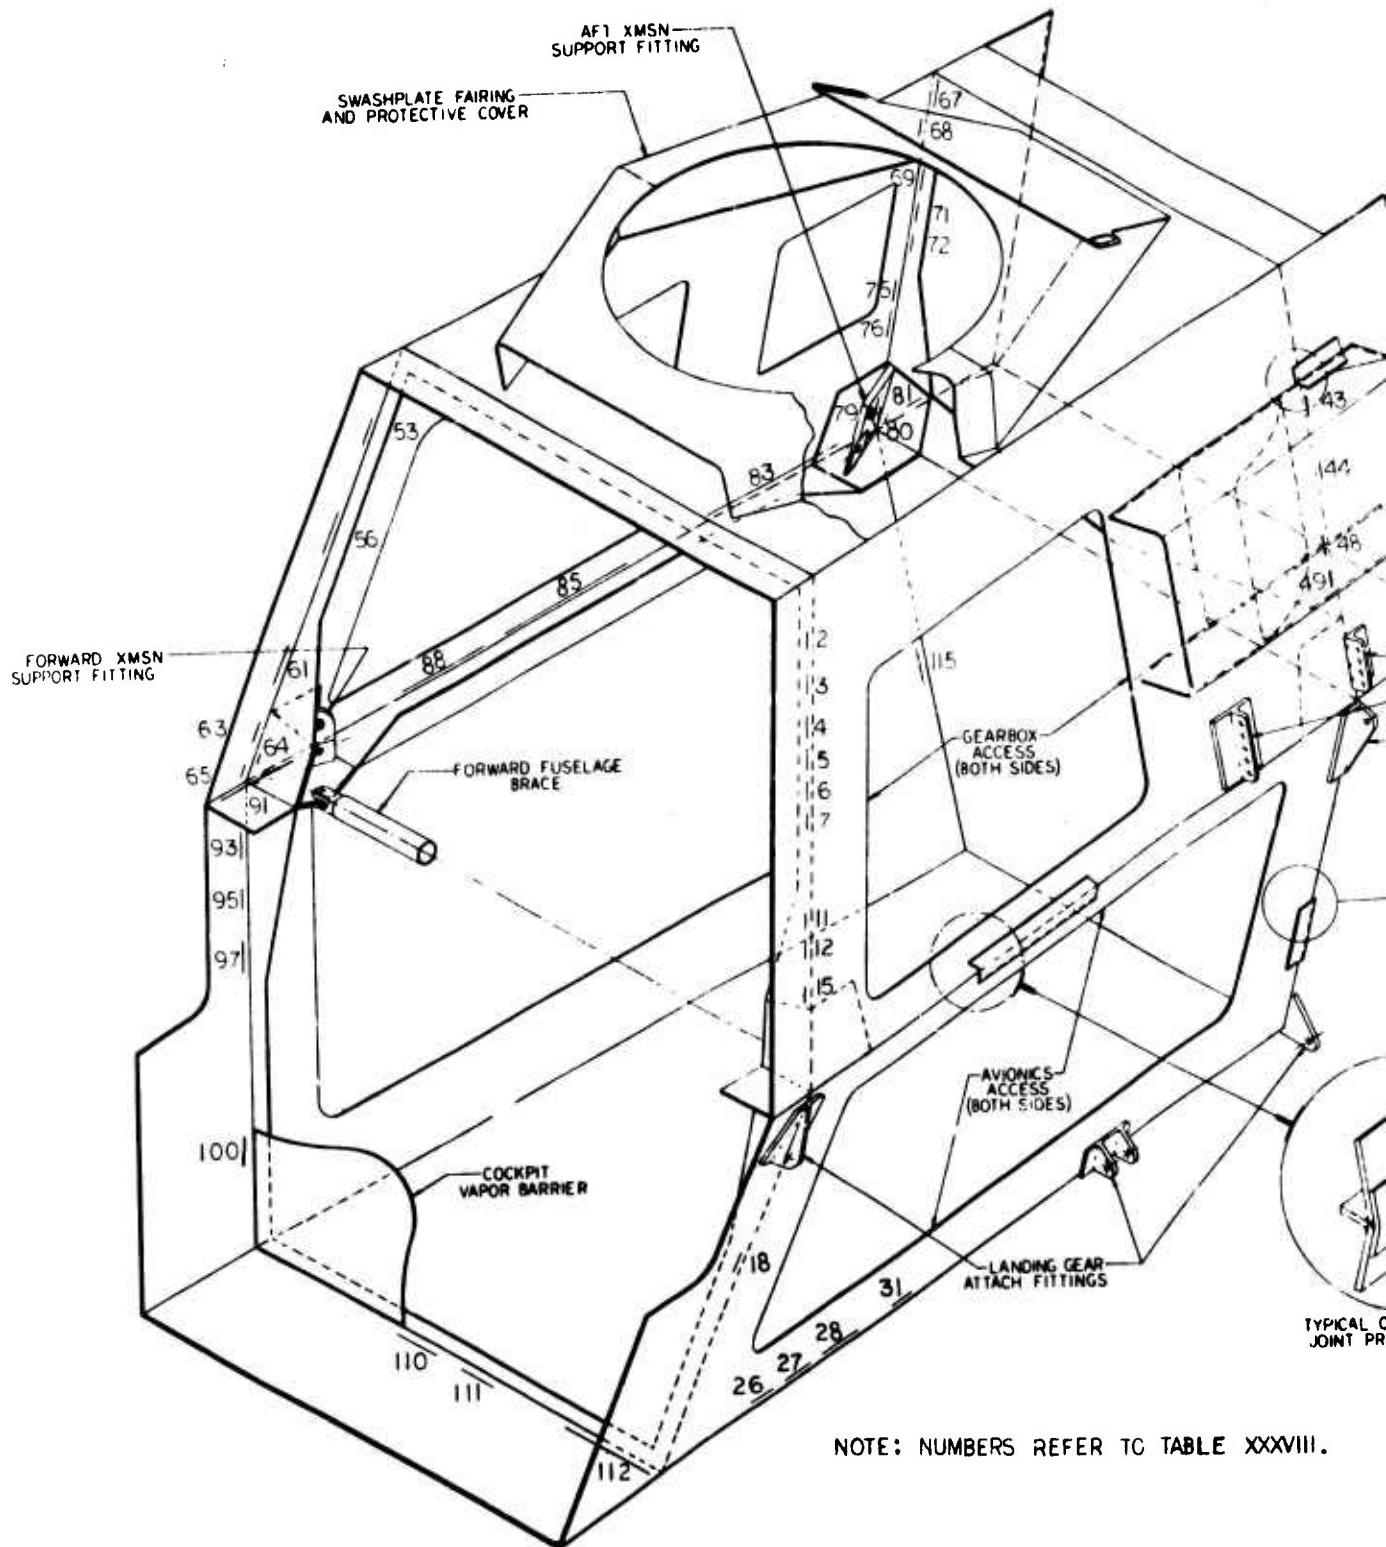
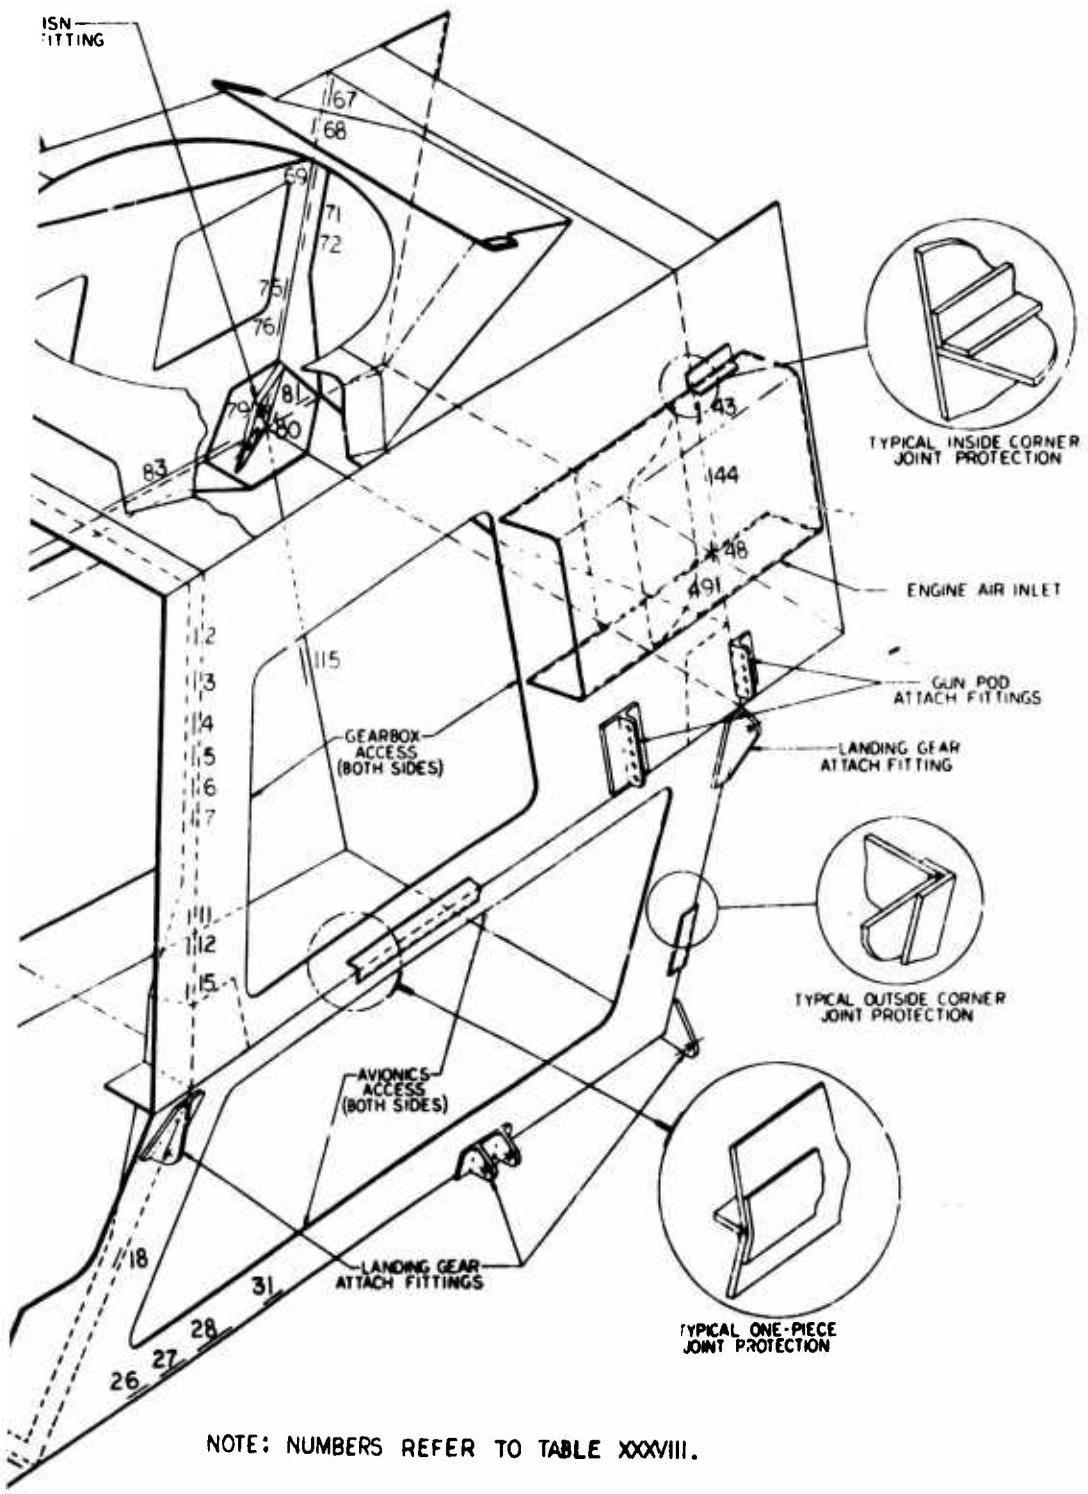
Figure 125. Crack Locations, Specimen 1.

At the completion of this repair procedure, the specimens were dye penetrant inspected and the location and extent of all cracks noted. The second specimen, where improved techniques were used, proved to have numerically more indications than the first (155 vs 117) but a reduced total crack length (186 inches vs 267 inches). All cracks are listed in Tables XXXVIII and XXXIX. As may be seen from Figure 124, 60% of the cracks in the second specimen were under 1 inch in length, many of them only spotty or hazy indications. The locations of the cracks are noted in Figures 125 and 126 by reference to the tables. For clarity, only those over 2 inches in length have been shown.

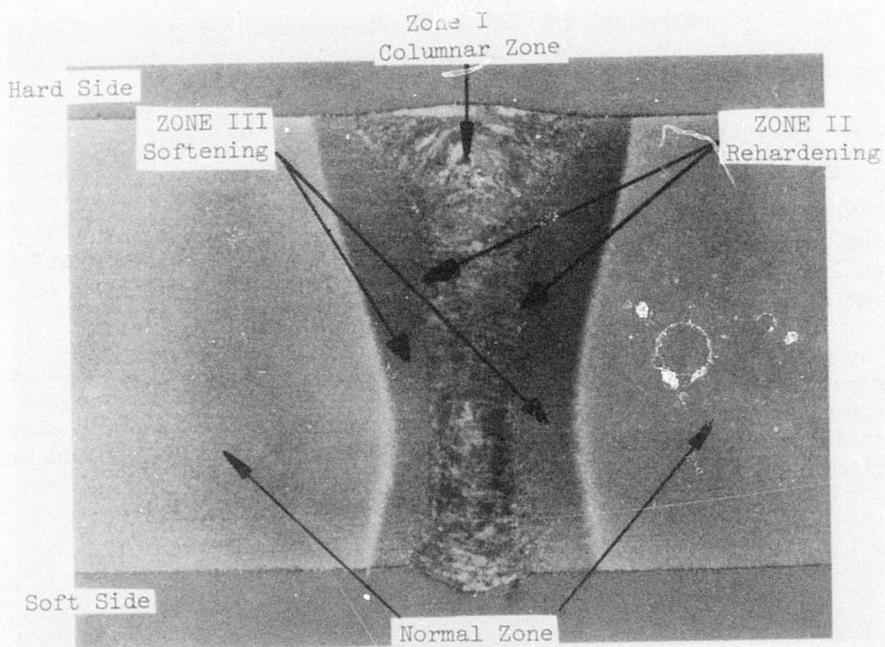
Figure 127. Laser Weld Cross Section, 9X.

Metallurgical examination revealed full penetration in all cases. Microscopic examination showed three distinct zones (Figure 127) — a columnar central zone where melting had occurred, a narrow rehardened zone, and a small softened zone. One of the most promising features was the hardness profile shown in Figure 128. The total heat-affected zone was typically less than 0.5 inch, with a minimum face hardness of R_c 43. By comparison (Figure 129), GTA welding typically results in a heat-affected zone of up to 2 inches, and a minimum face hardness of R_c 32. These properties suggest that laser welded armor might not require additional joint protection.

Although some tendency toward fusion line cracking up to 0.040 inch deep was noted, this appears to be only a developmental problem. The achieved properties suggest that preheating and/or postheating techniques could be used while retaining acceptable ballistic resistance.

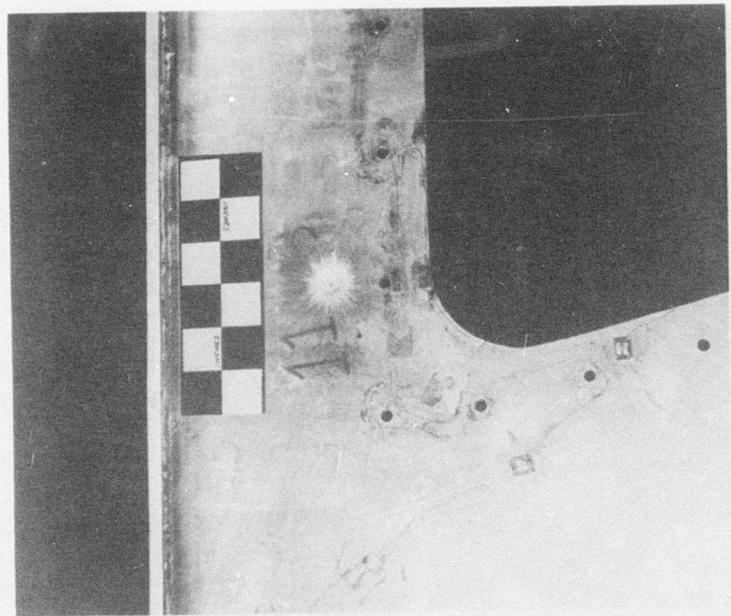
Figure 171. Ballistic Impact Zone,
Round 11, Ball Projectile.

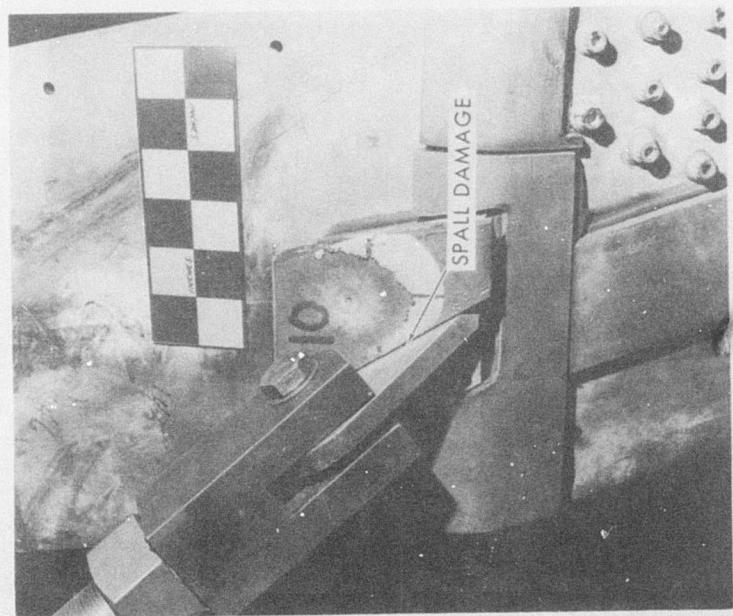
Figure 170. Ballistic Impact Zone,
Round 10, Ball Projectile.

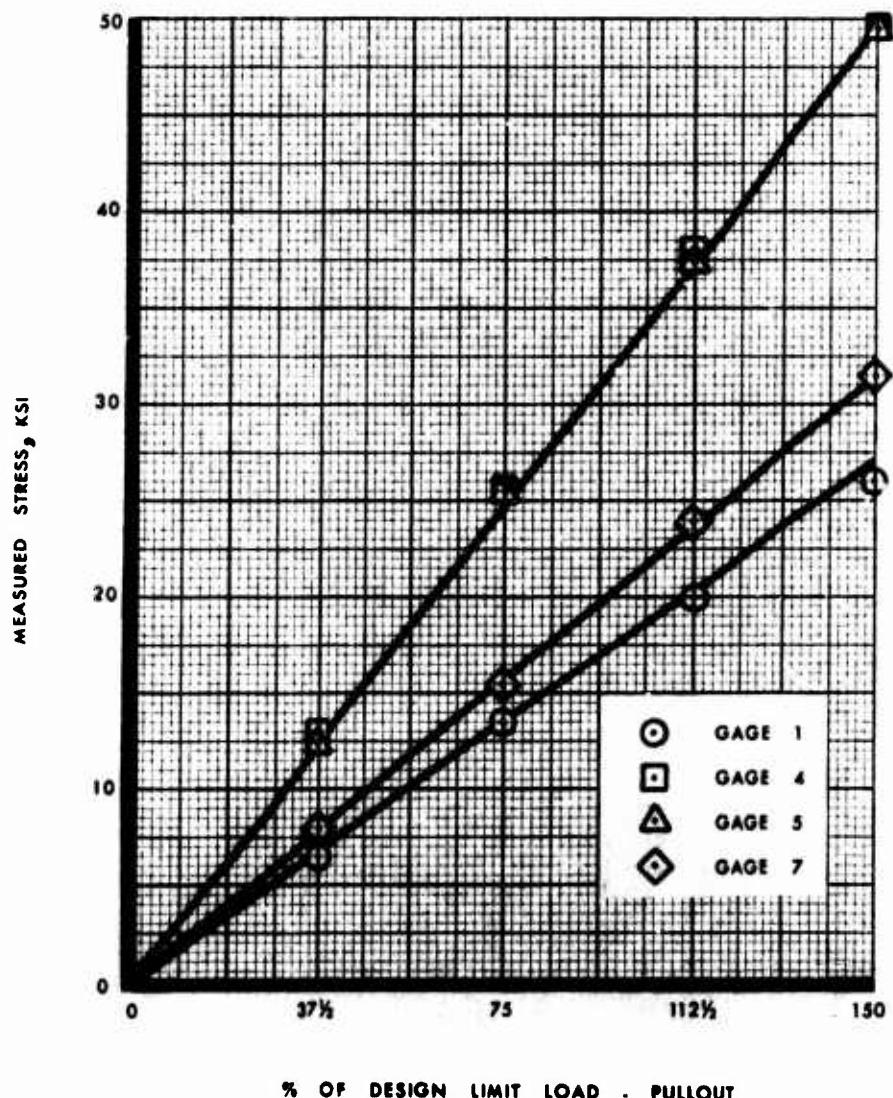
Figure 174. Residual Strength Test,
Measured Stress vs % of Design Limit
Load - Pullout.

A residual strength test to 150% of symmetrical pullout design limit loading was performed on completion of the 600-hour fatigue test. The specimen was loaded twice to 112% of design limit load and once to 150% of symmetrical pullout design limit load. Measured strains and deflections as well as visual observations showed no indications of yielding. The measured stresses are plotted in Figure 174.
